CONSTRUCTION STORMWATER GENERAL PERMIT INSPECTION REPORT

State of Washington Department of Ecology

The Electron Hydro LLC Intake project is covered under the State of Washington's Construction Stormwater General Permit (CSWGP). The CSWGP is a National Pollutant Discharge Elimination System (NPDES) and a State Waste Discharge permit for discharge of construction-related stormwater. Carol Serdar had previously been to the site a few years' prior, during the JARPA review for the then proposed construction of the barrier dam and intake structure.

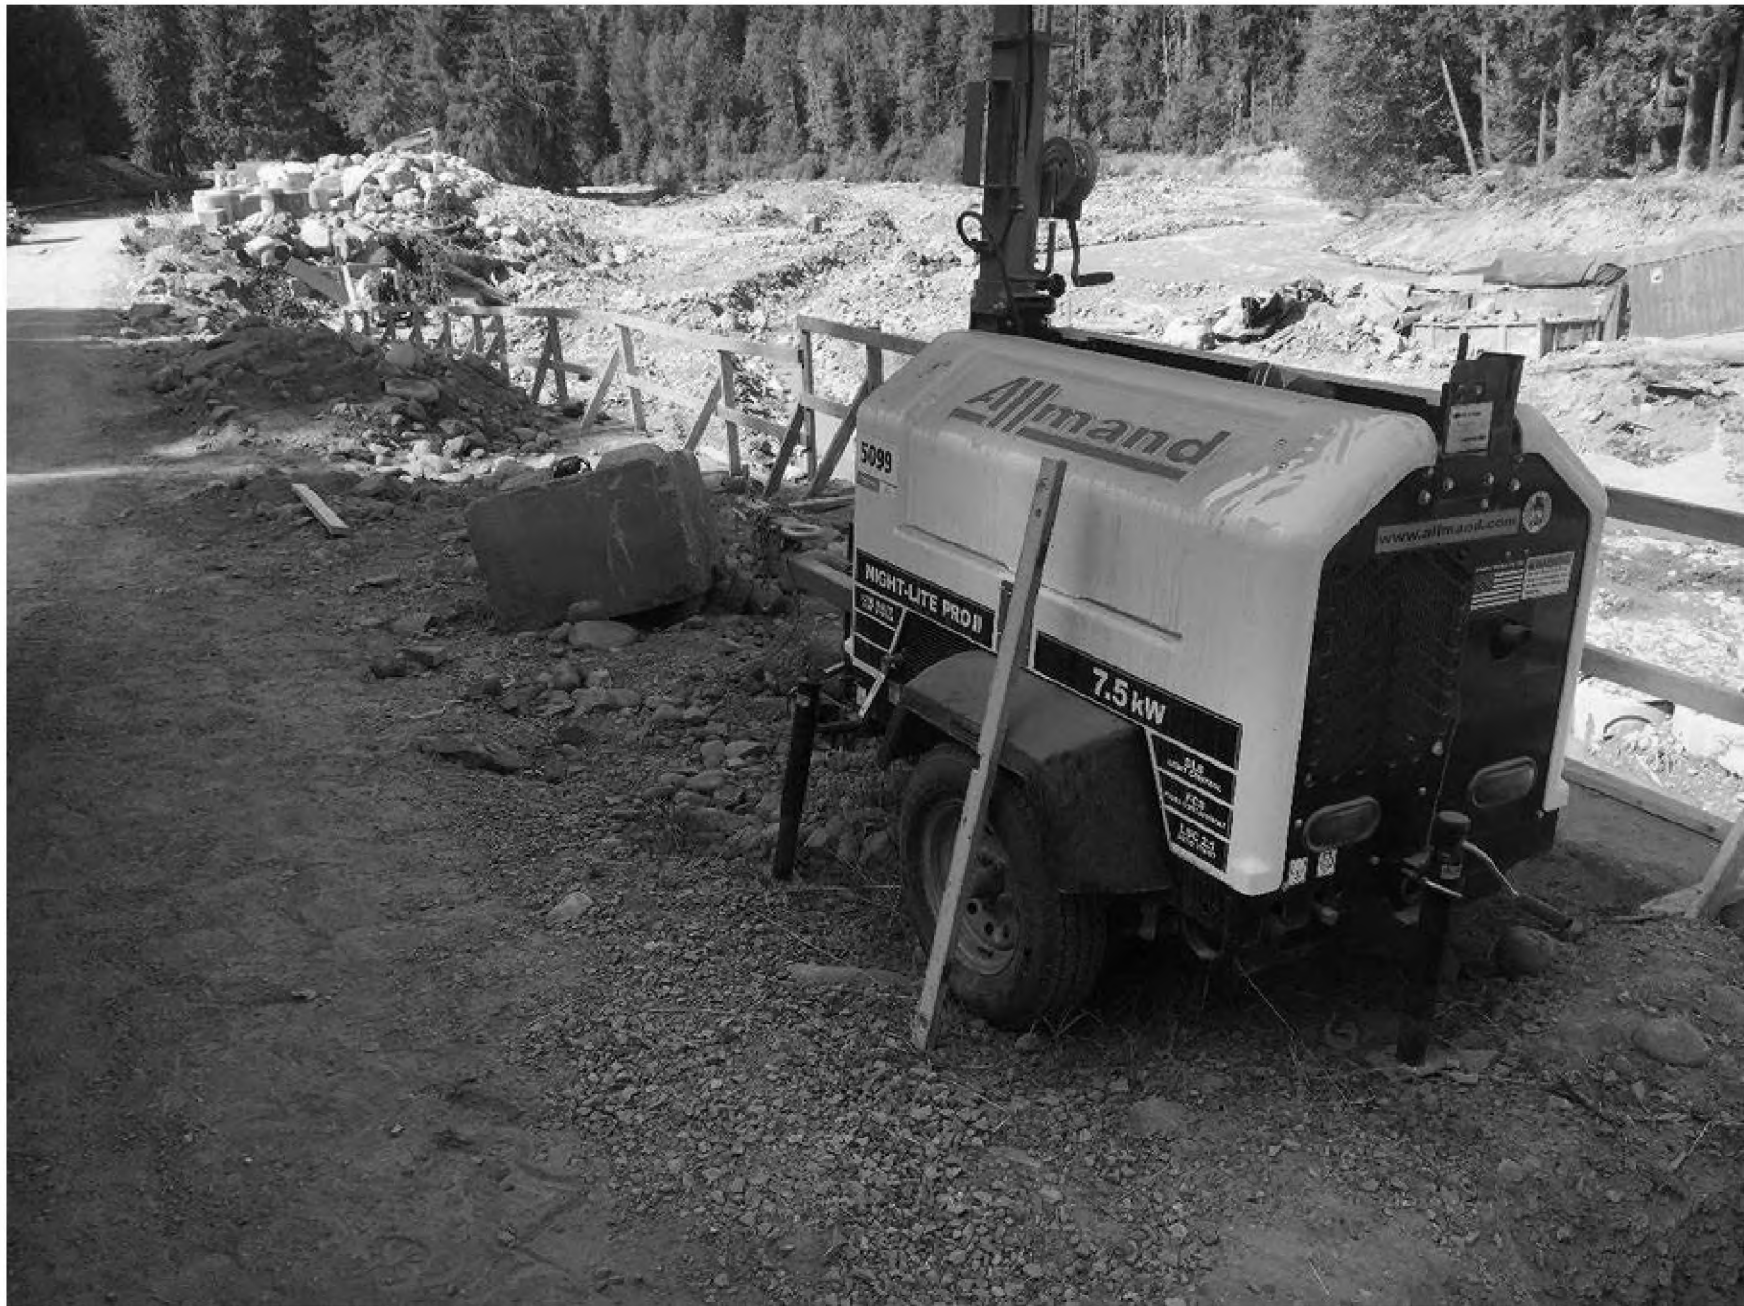
Photo 1

Light pole with generators appeared to not have secondary containment, on closer inspection, the light poles have built in secondary containment. Other generators, including a large one for the pumping of dewatering water in construction zone, do not have secondary containment. Secondary containment is a requirement of CSWGP condition S9.D.9.b. (secondary containment means placing tanks or containers within an impervious structure capable of containing 110% of the volume contained in the largest tank within the containment structure).

Photo Description: Light pole with generator has built in secondary containment.

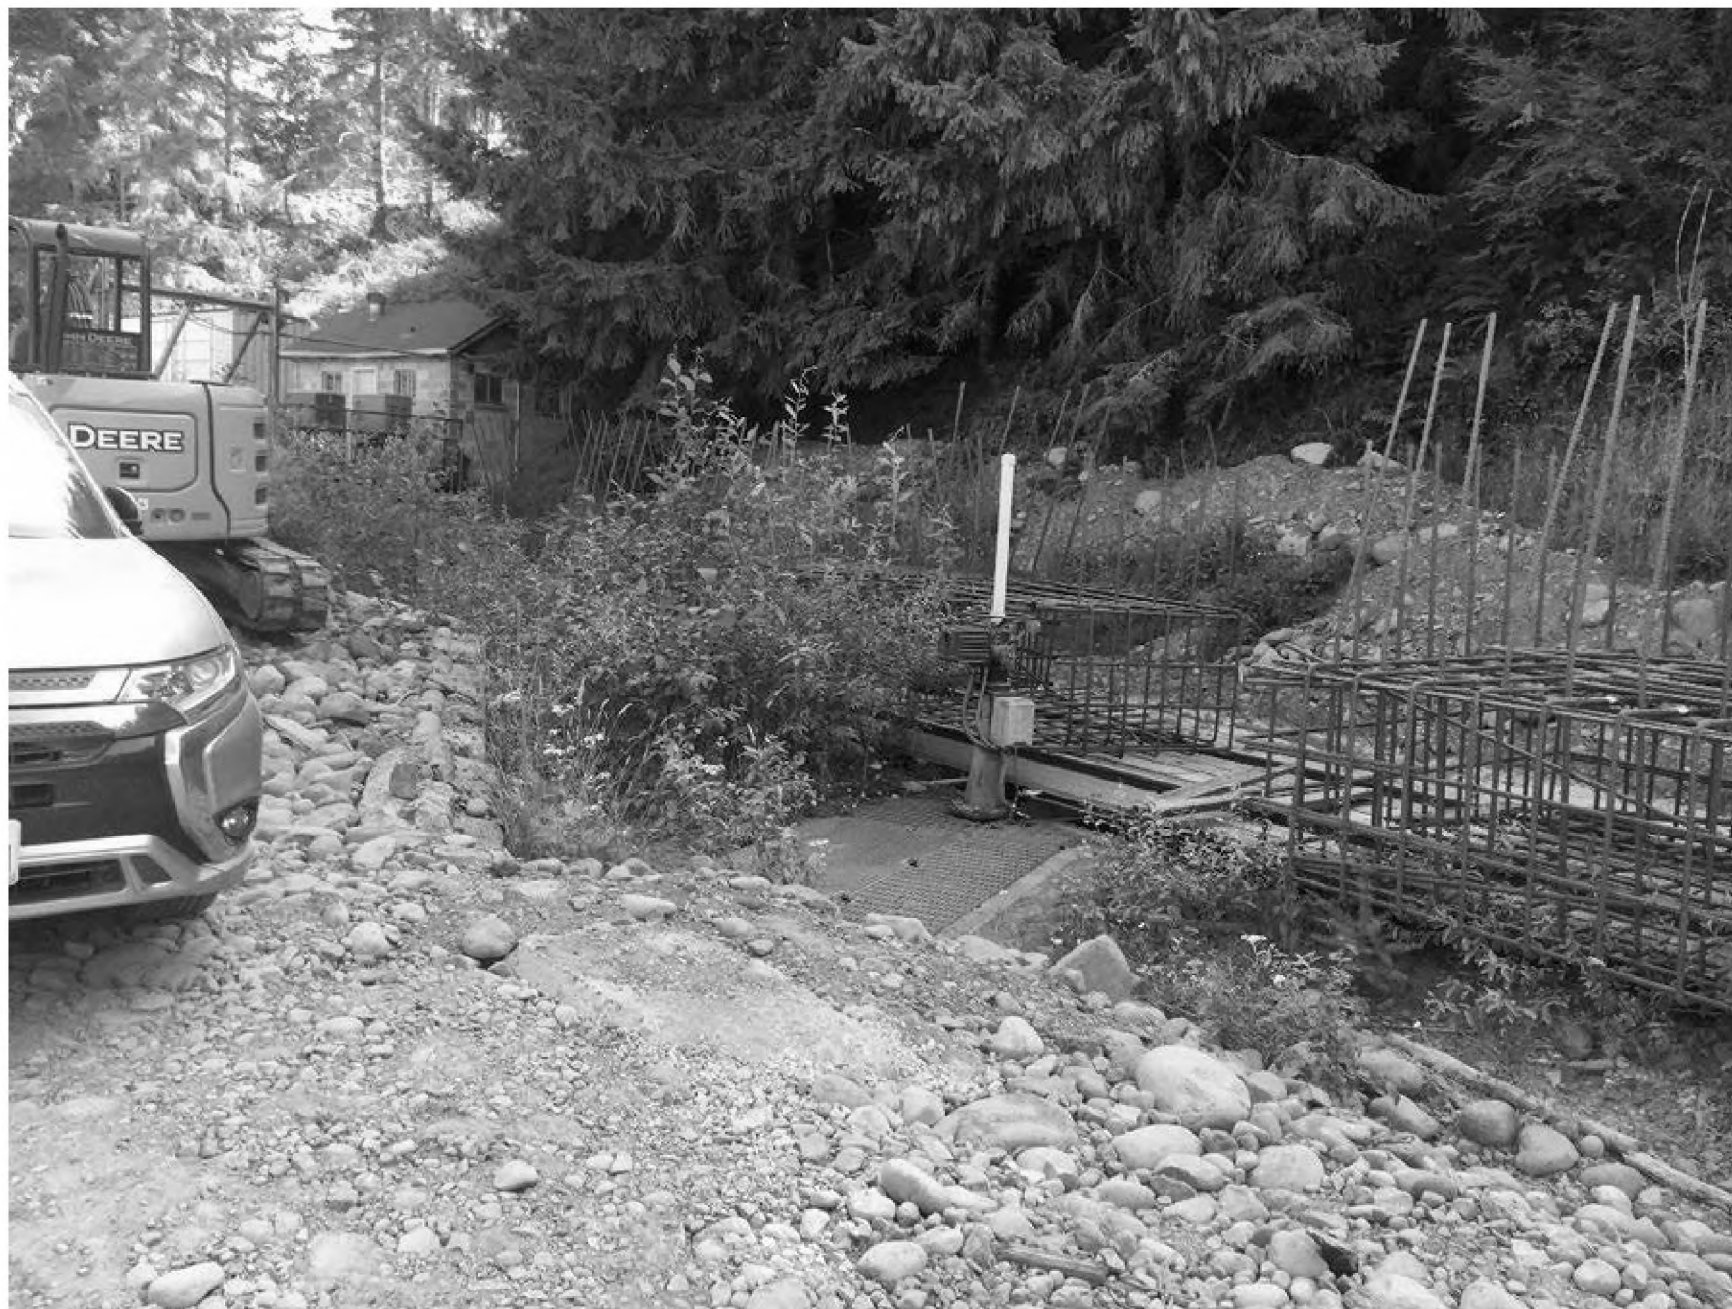
Photo 6

The long, bare/exposed and unworked soil slopes from the road down toward the Ordinary High Water (OHW) of the Puyallup River was discussed and based on the CSWGP must be stabilized within seven days (CSWGP condition S9.D.9.d.); the driving surface of the road consists of fine silt/dirt which likely will cause a significant discharge into waters of the state at the first storm event. Thom agreed the road surface needed to be modified and we discussed BMP options.

Photo Description: Fine silt/dirt and rounded river rock is the haul route surface.

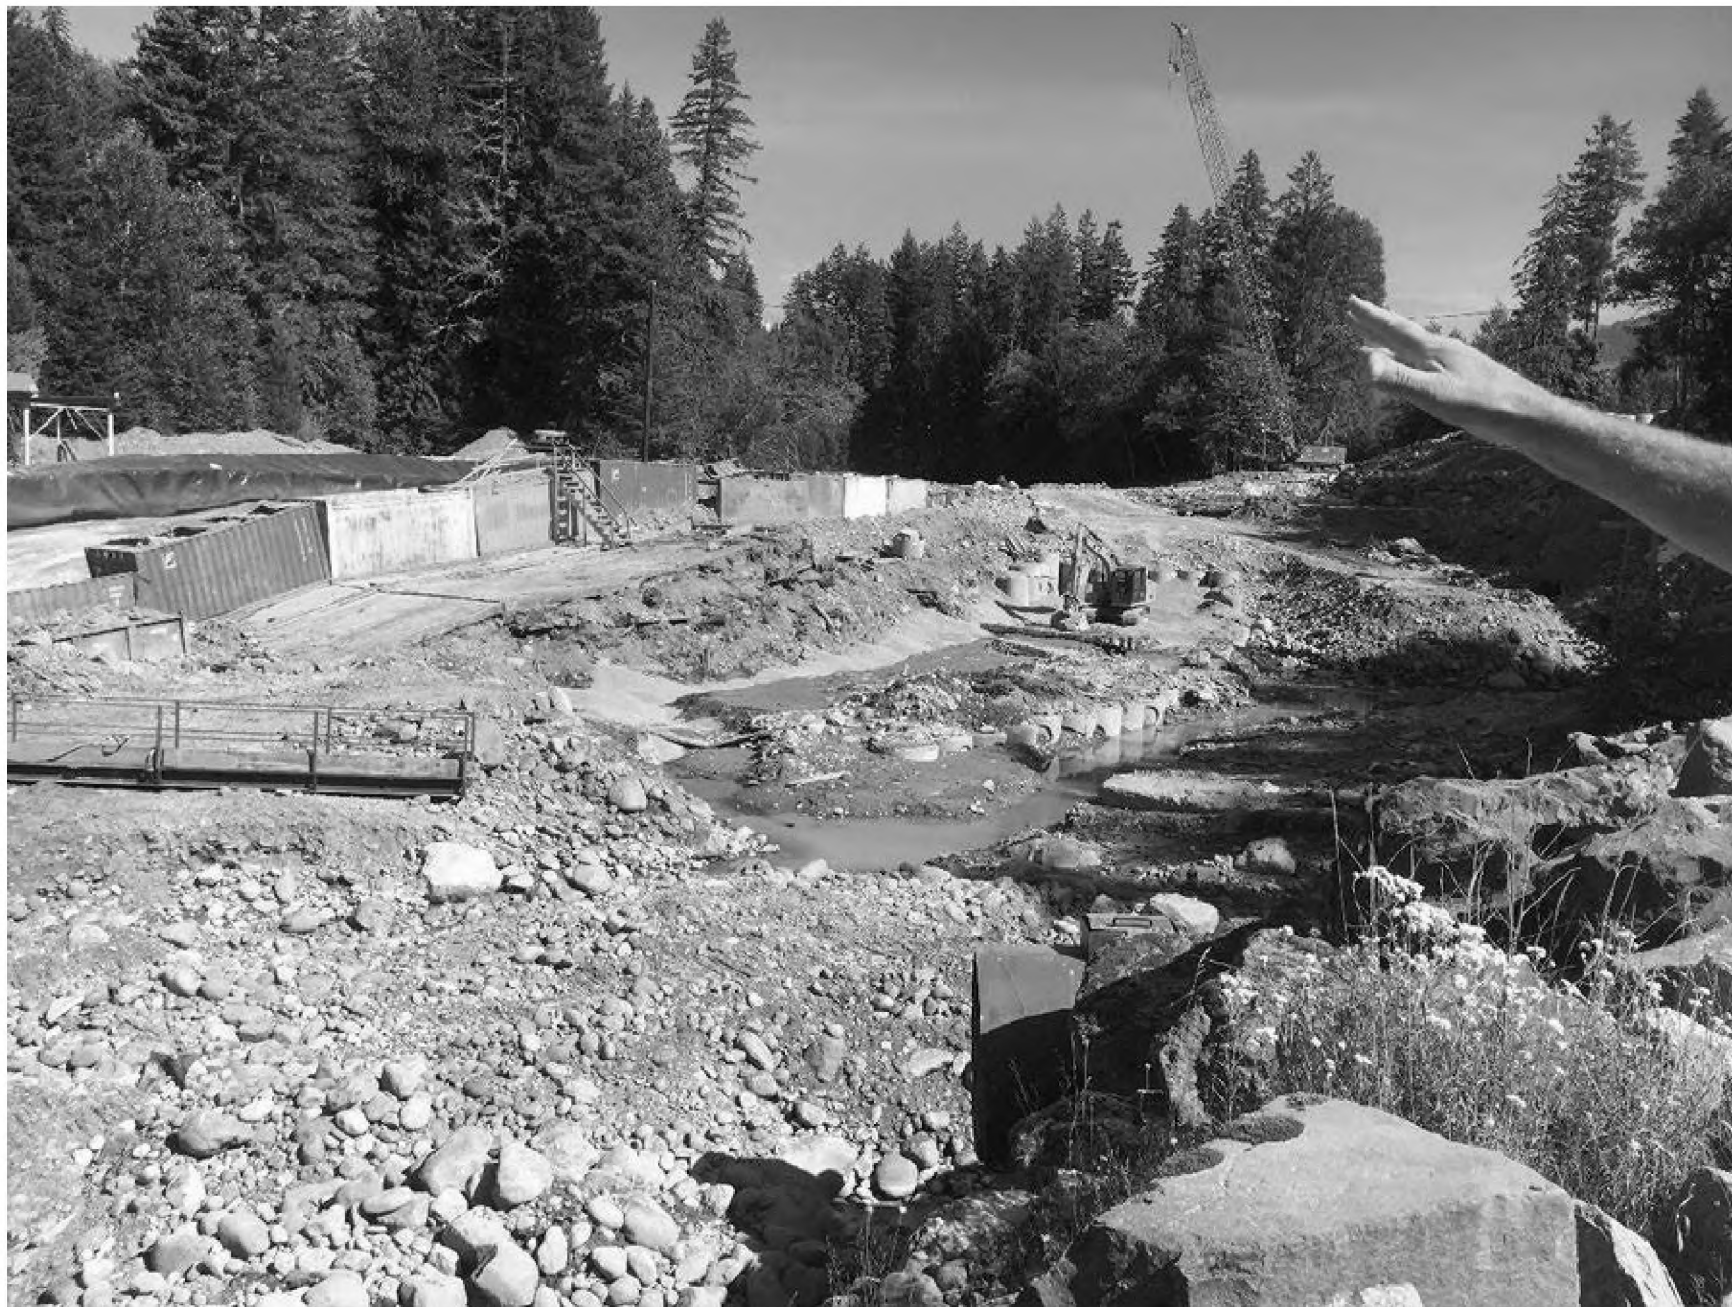
Photo 7

Photo Description: The Puyallup River is located flowing toward the left behind the old wood dam with truck containers. Note the construction zone depth below the channelized river.

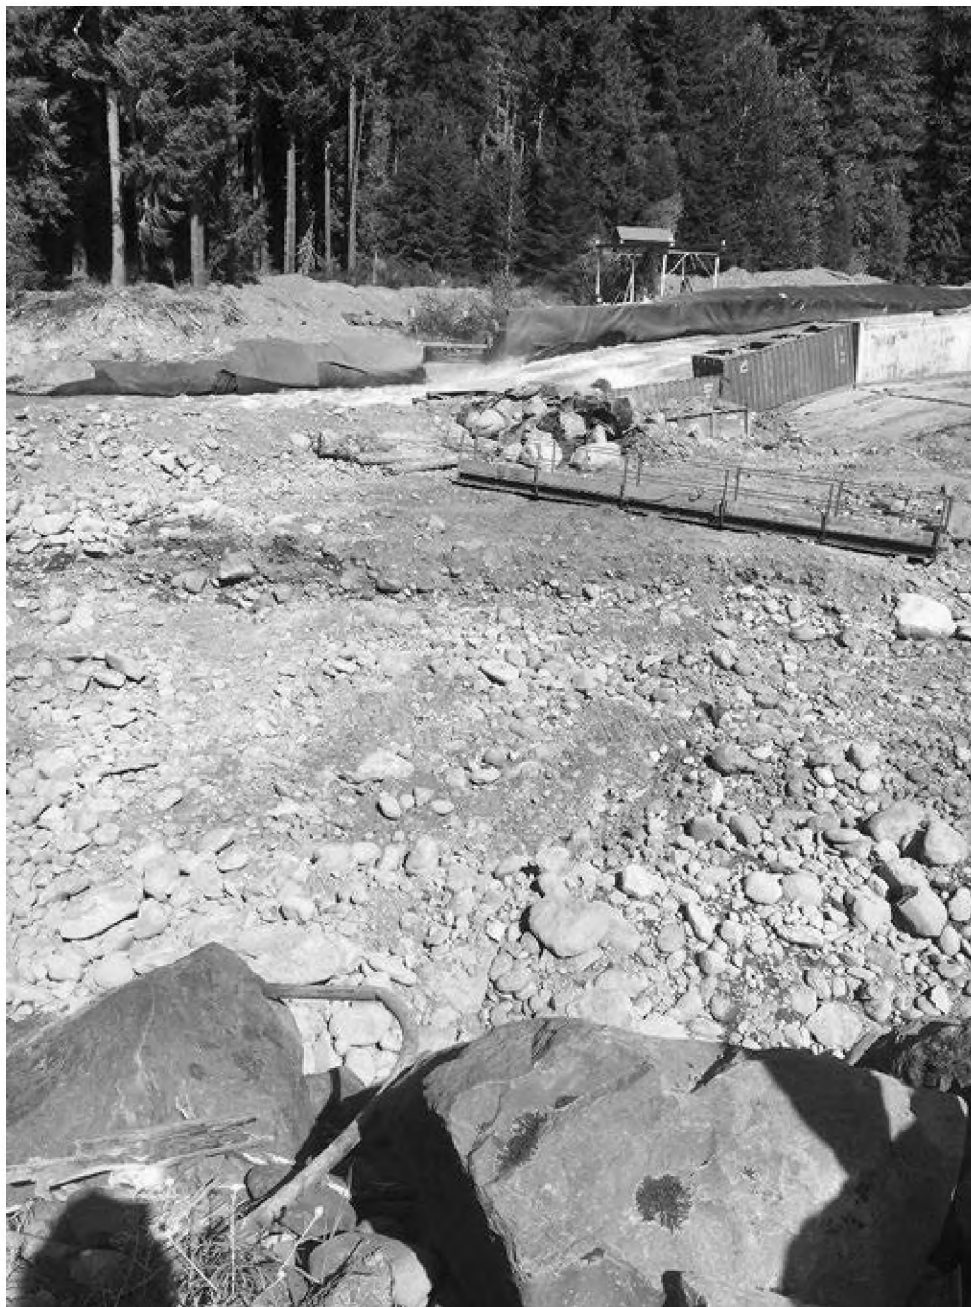
Photo 8

Photo Description: End of channelized river, location of sports turf that the river undercut and moved portions of the turf downstream.

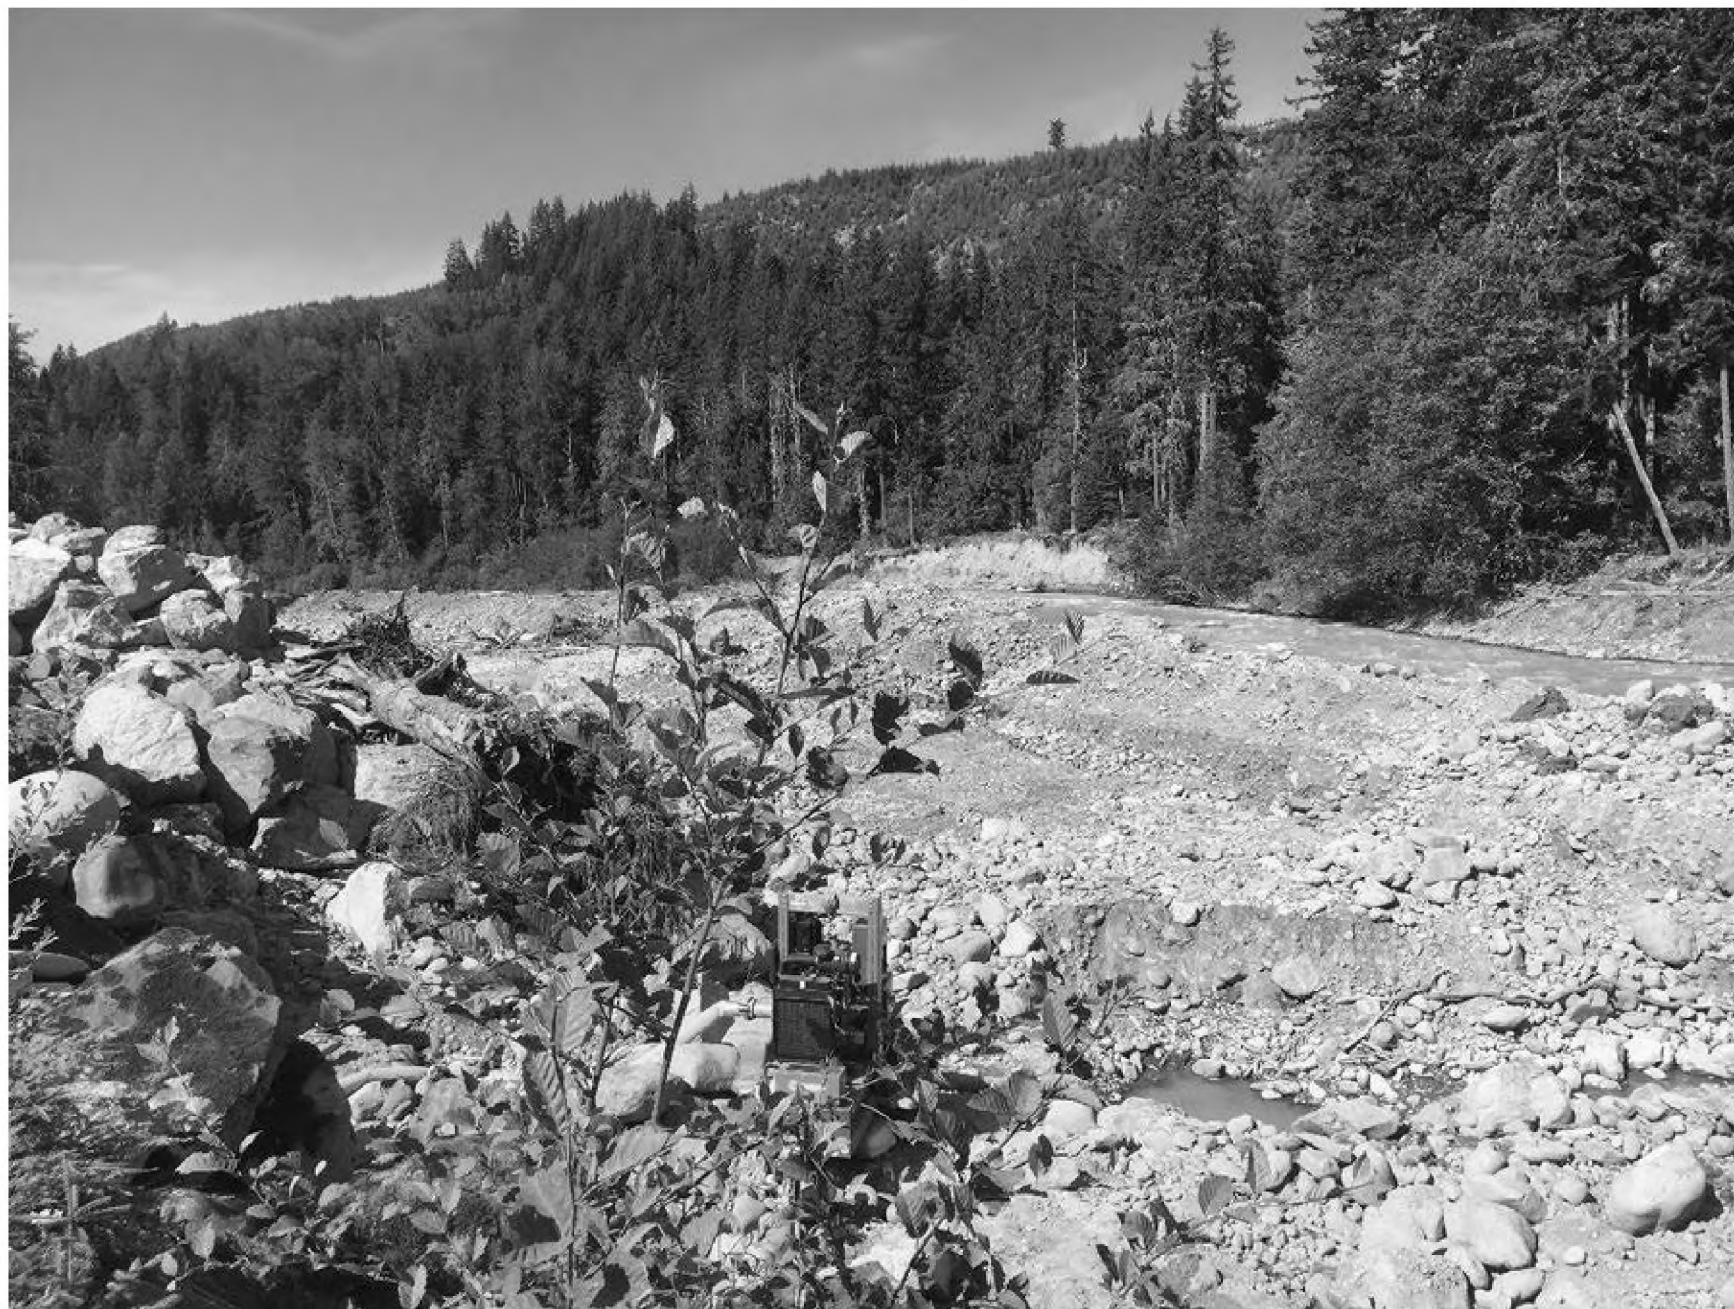
Photo 9

Photo Description: Looking downstream.

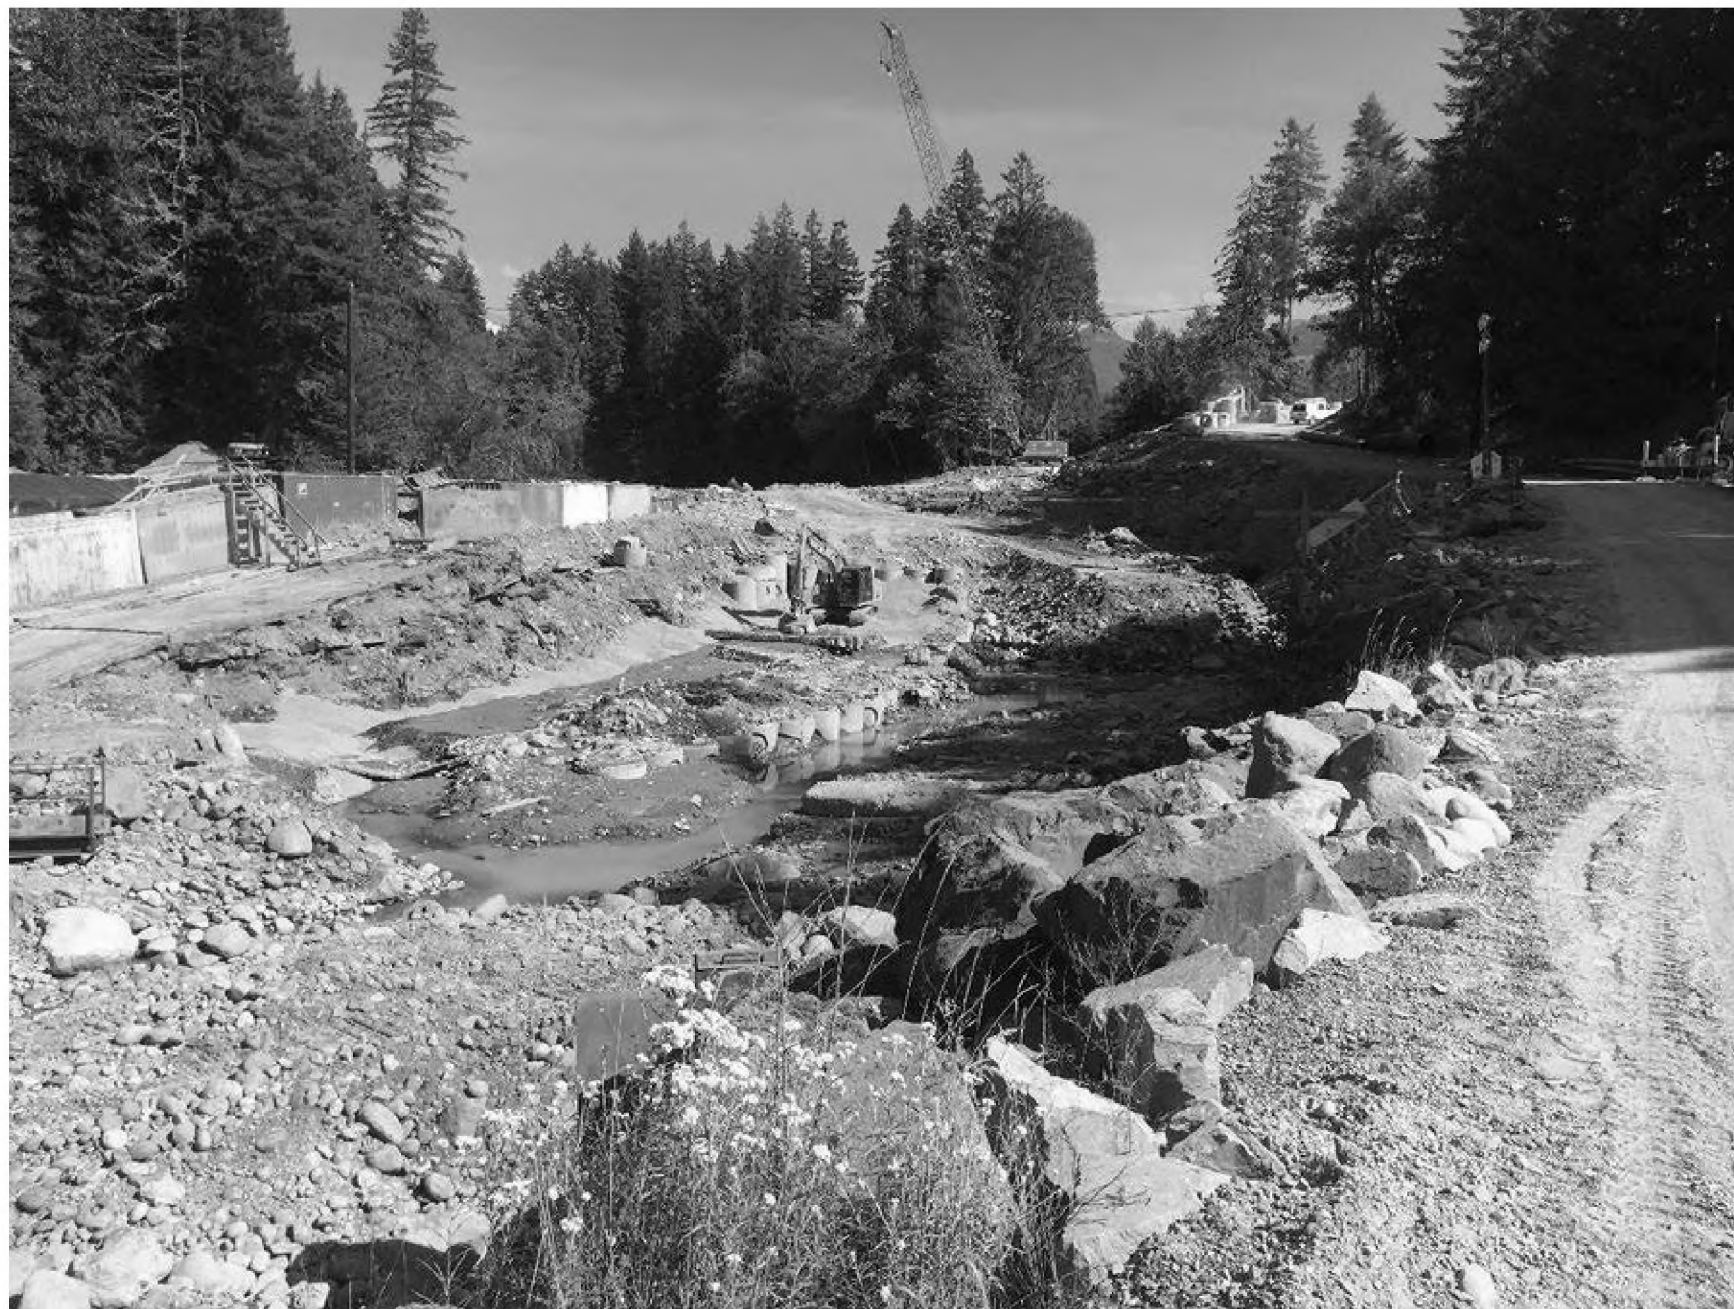
Photo 10

Photo Description: No BMPs along haul road and side slopes; during storm events, this slope will likely deliver additional turbid water to the construction area in the riverbed.

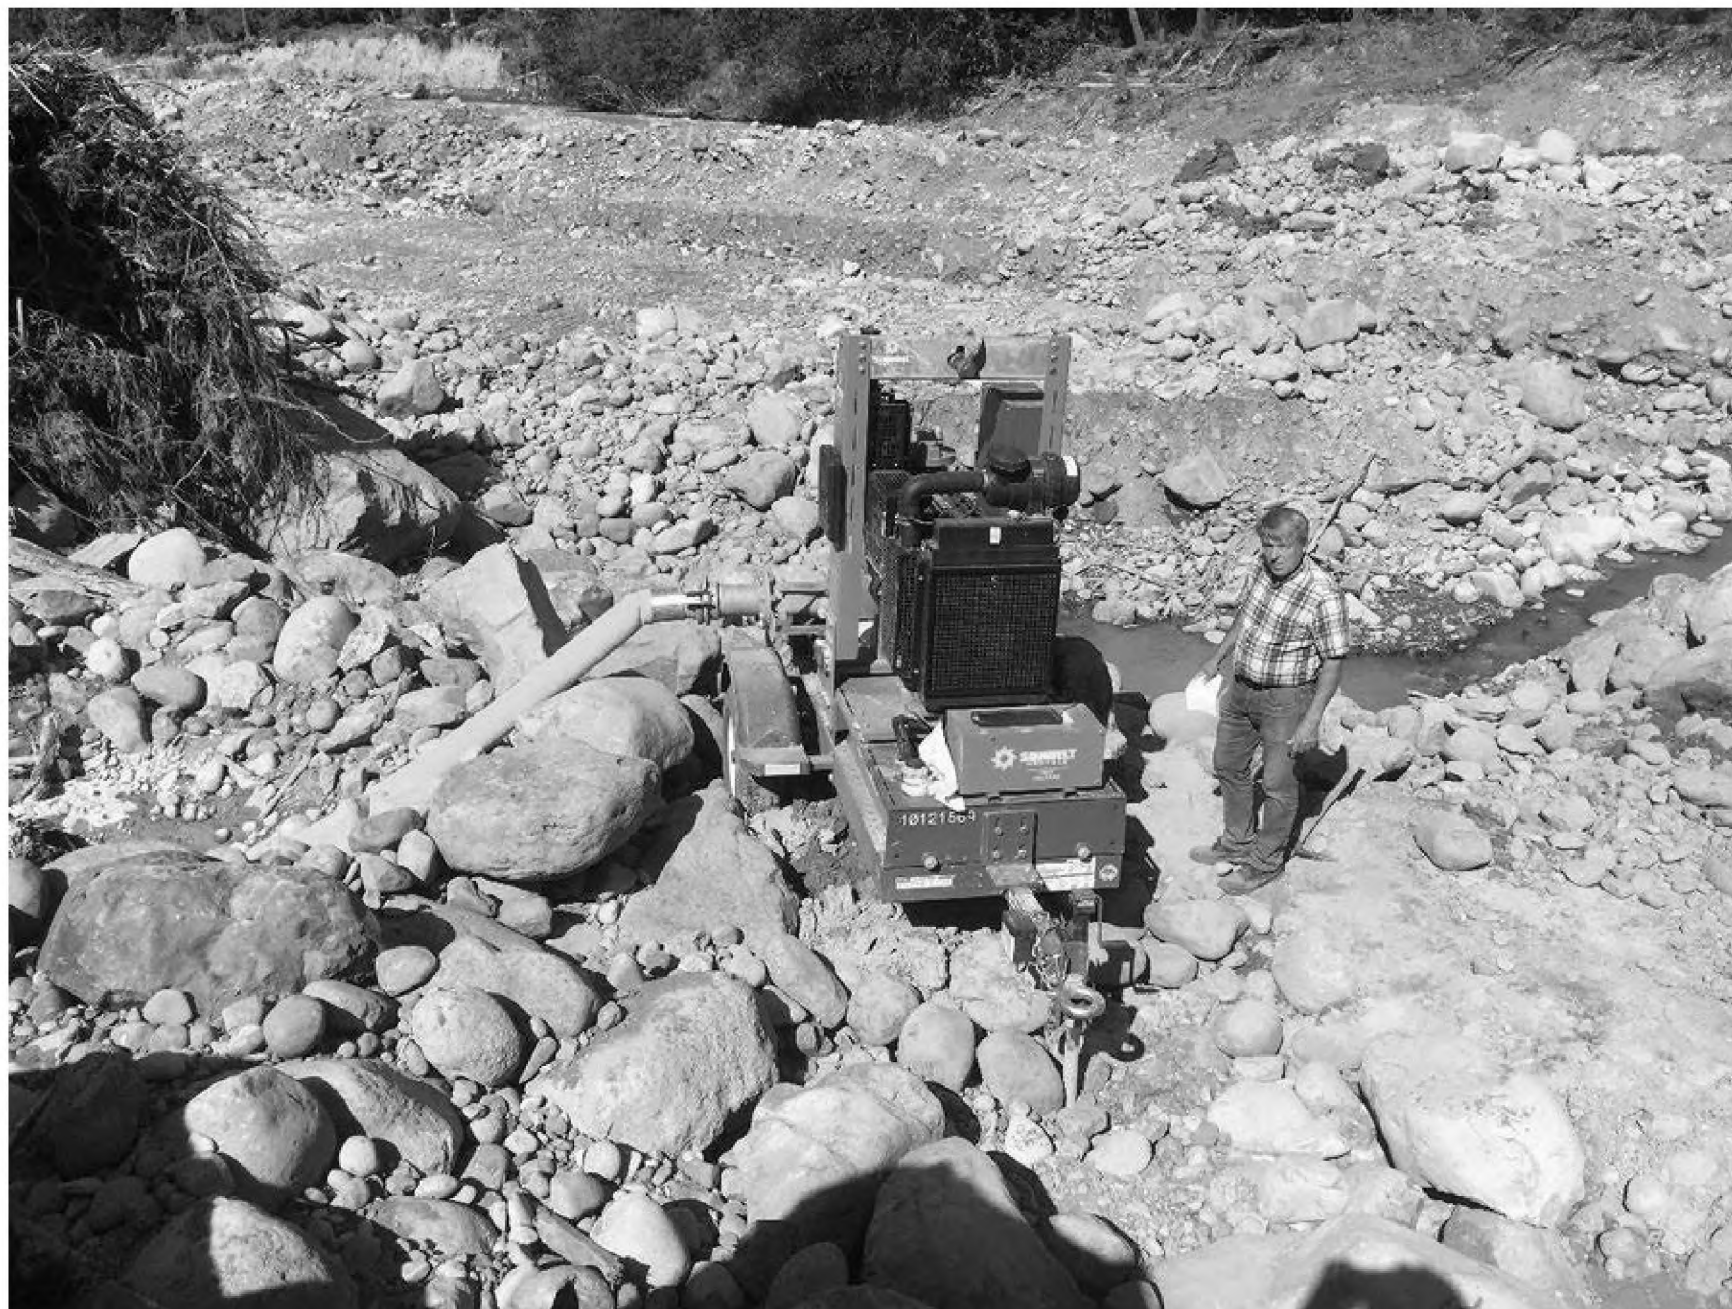
Photo 11

Photo Description: In water construction zone pump for dewatering has no secondary containment for (110% capacity) of the fuel in the generator.

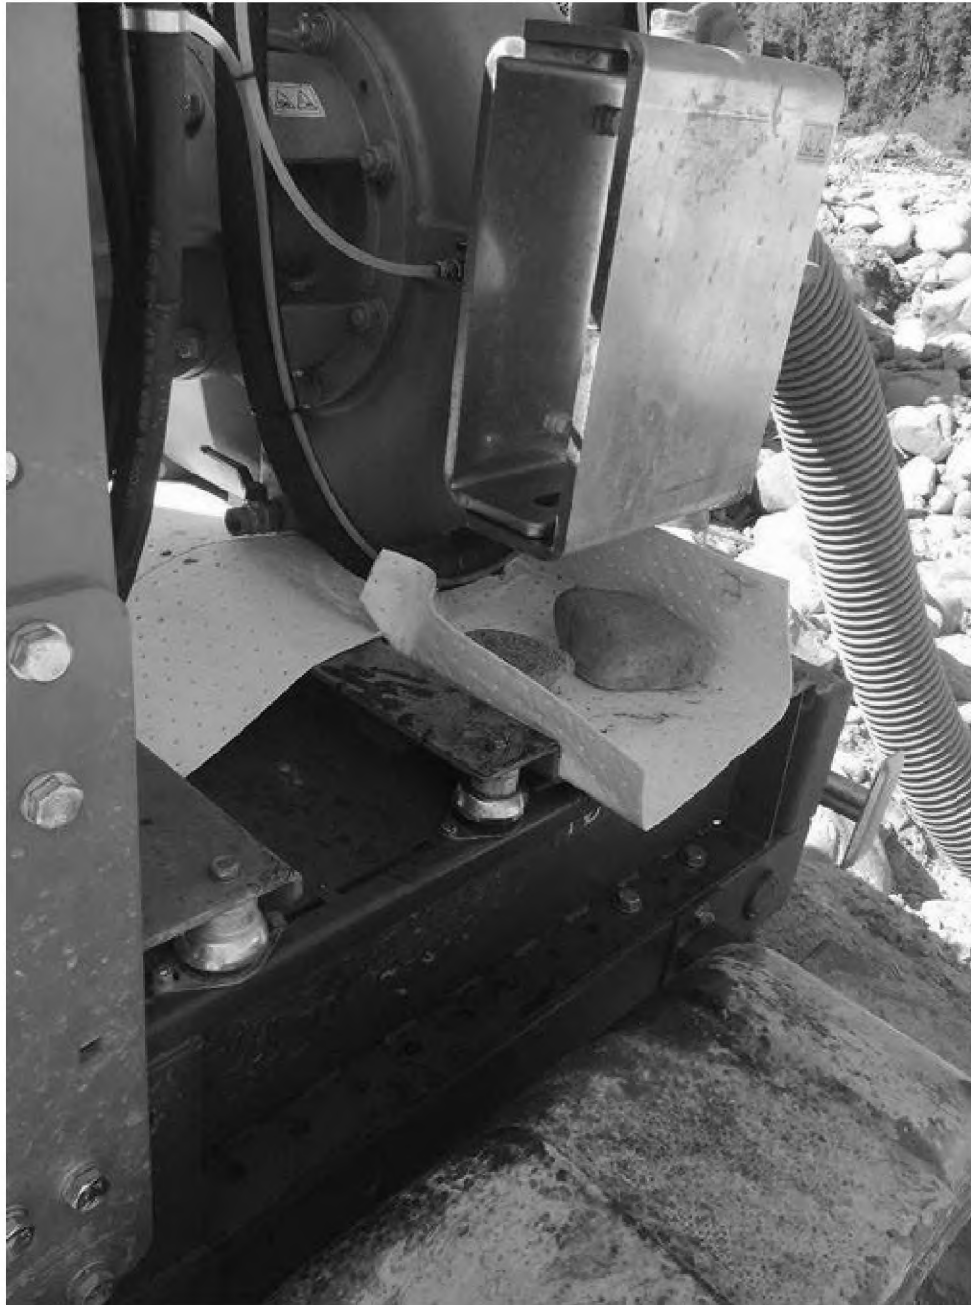
Photo 12

Construction stormwater management was explained: water from upland staging and dewatering water from the construction zone in the riverbed are comingled in the CSWGP stormwater system. This system includes a conveyance ditch near the base of the hillslope, sediment pond containing an outlet structure, which when overflows, drains to the stormwater pond. Water from the stormwater pond is settled out through a series of weirs constructed of straw bales. Discussed that although many sites use straw bales, the usage of straw bales as a BMP were removed from the Stormwater Management Manual of Western Washington (SWMMWW) in 2014. Use of the 2019 SWMMWW is now the requirement of the CSWGP (as of 31 December 2020 – CSWGP revision in process now).

Photo Description: Generator for pumping water from the construction zone; water is pumped to CSWGP stormwater management BMPs (conveyance ditch, sediment pond, then stormwater pond); river water is comingled with construction water.

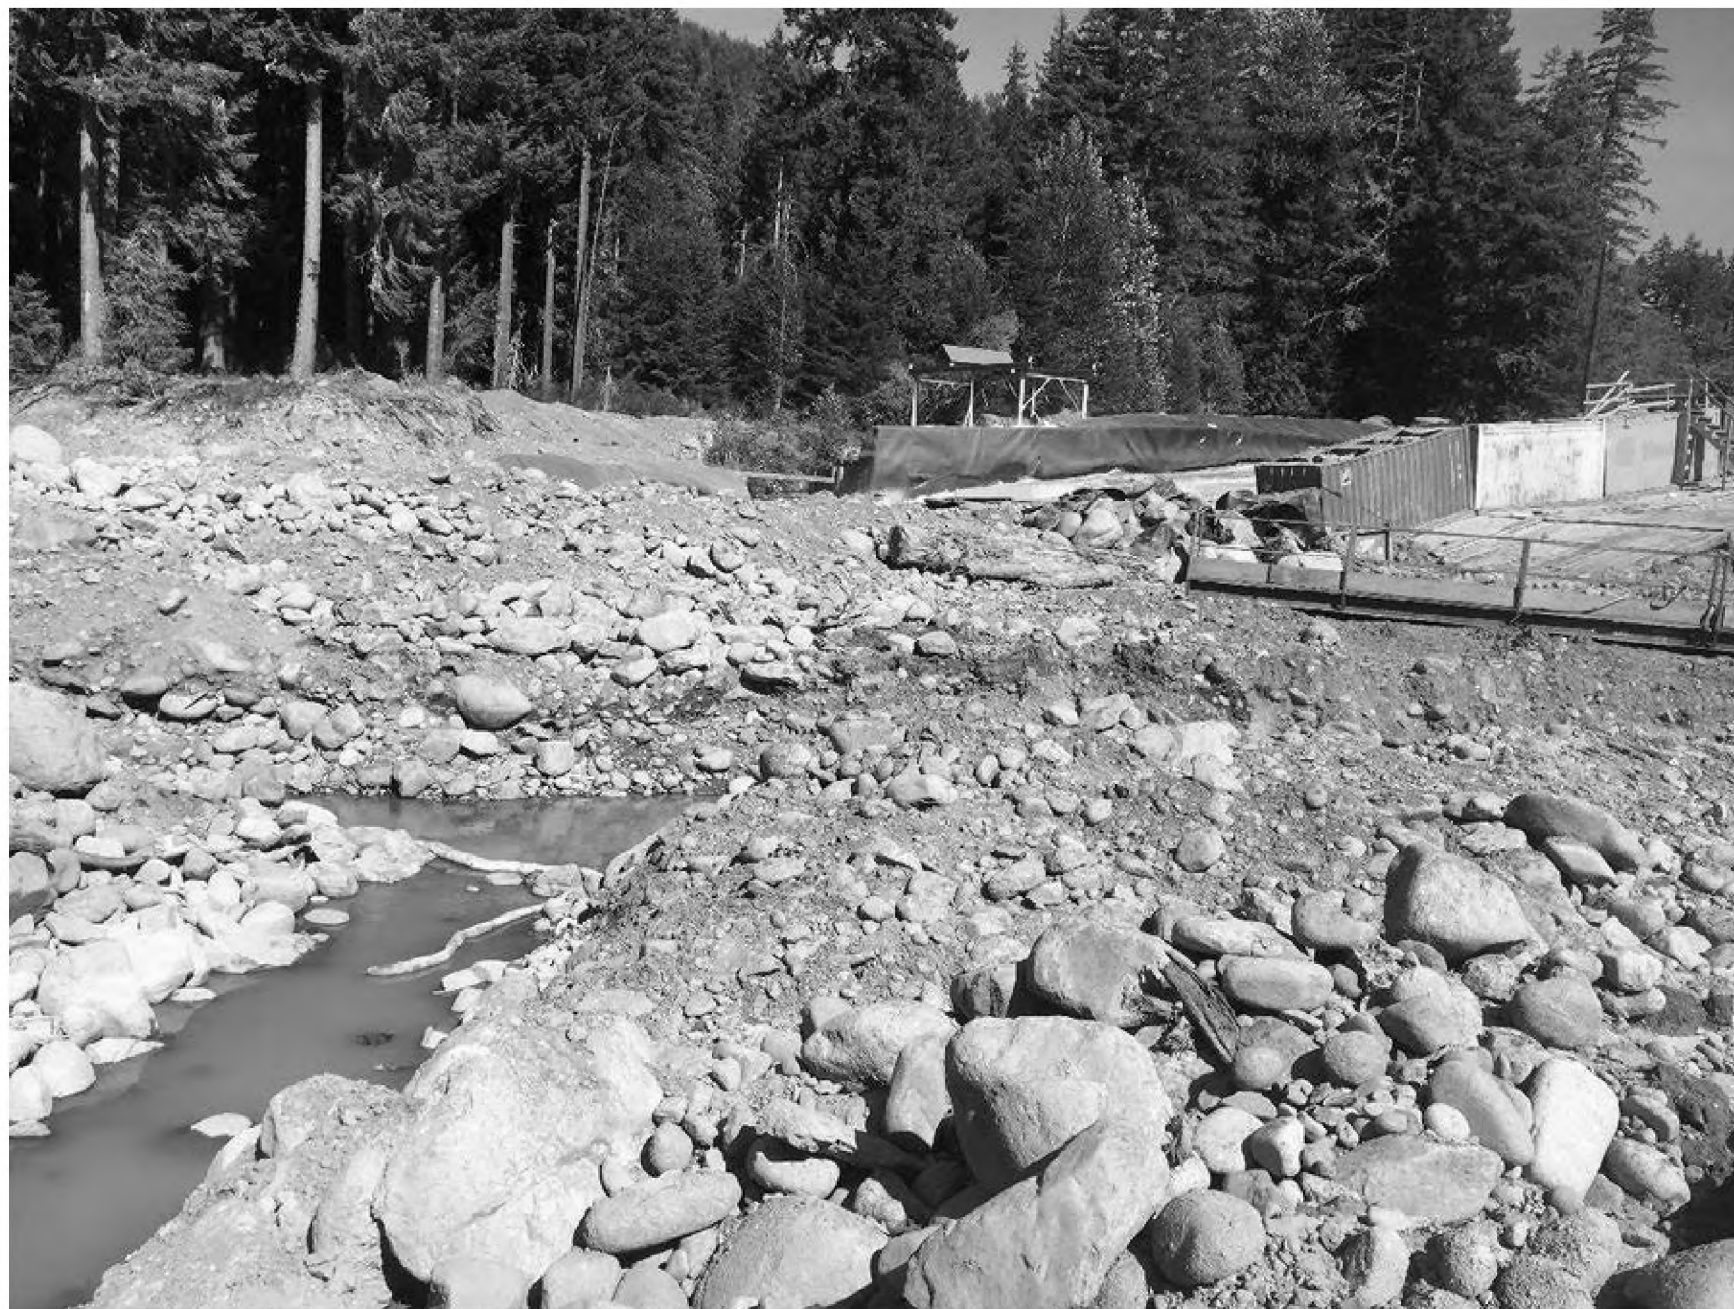
Photo 13

Photo Description: Oil booms are not functional when not secured as intended.

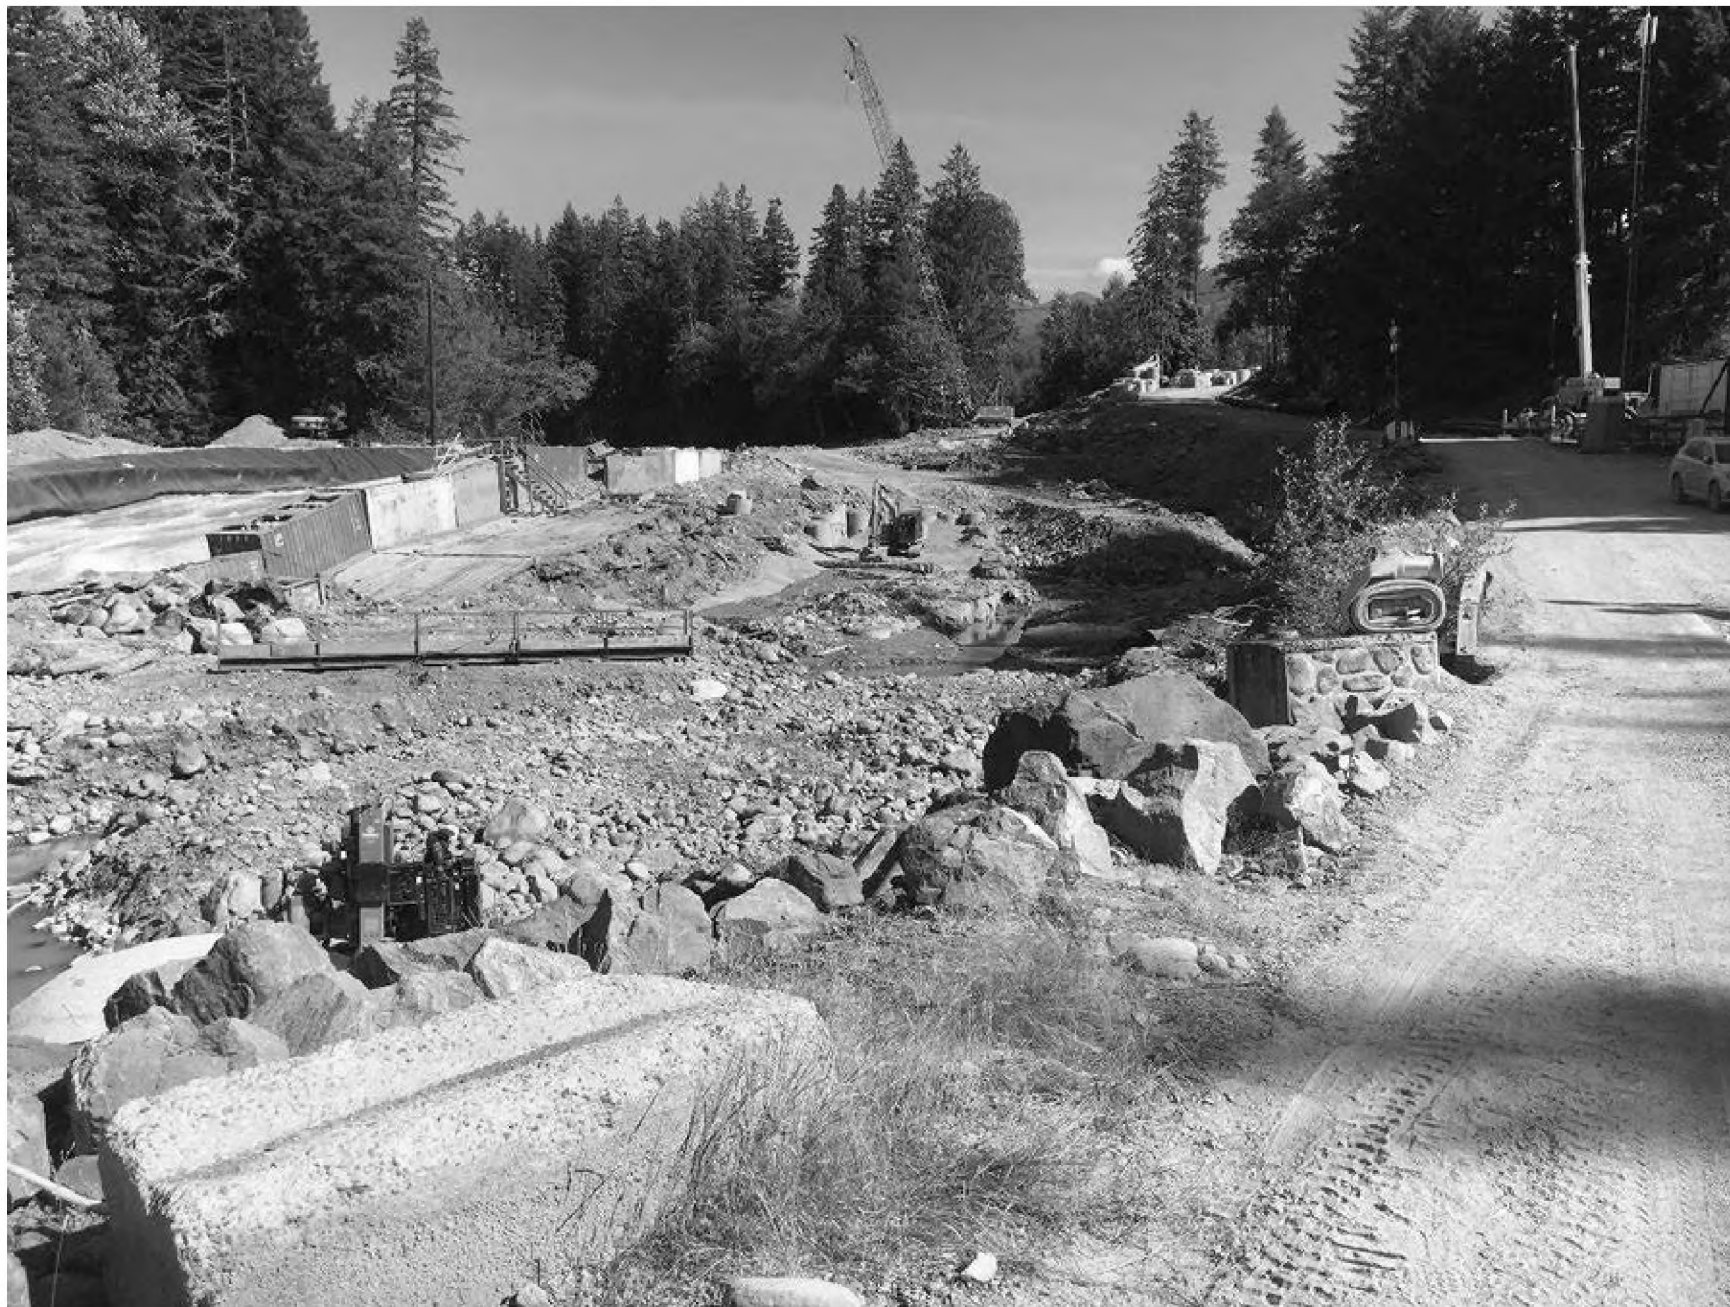
Photo 14

Photo Description: Upland haul road and construction zone in the Puyallup riverbed.
